ANNUAL REPORT FOR 2010

**UT to Middle Fork Creek Site F Mitigation Site
Madison County
TIP No. R-2518A**

Prepared By:
Natural Environment Unit & Roadside Environmental Unit
North Carolina Department of Transportation
December 2010

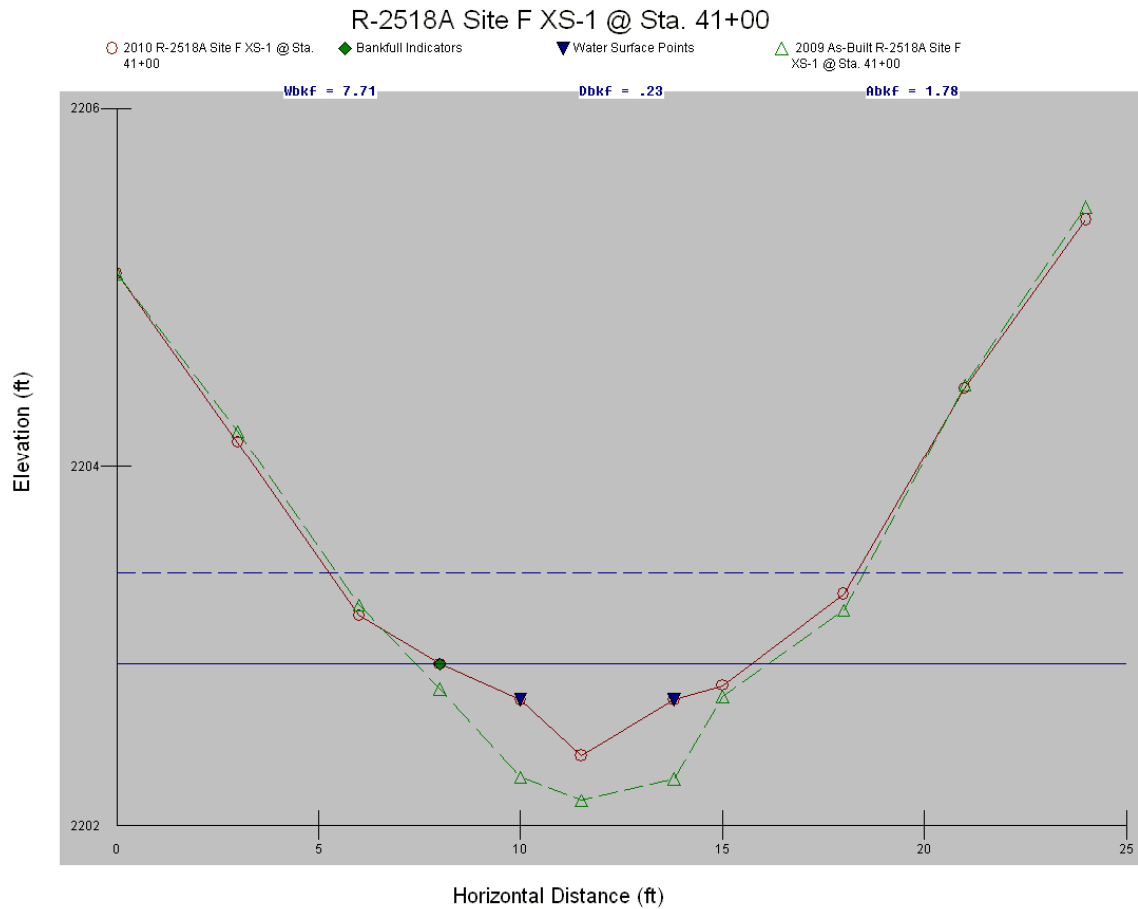
Site F: Cross-Section #1 (Riffle) Abbreviated Morphological Summary					
	2010	2011	2012	2013	2014
Bankfull Cross Sectional Area (ft ²)	1.78				
Maximum Bankfull Depth (ft)	0.51				
Width of the Floodprone Area (ft)	13.06				
Bankfull Mean Depth (ft)	0.23				
Width/Depth Ratio	33.52				
Entrenchment Ratio	1.69				
Bankfull Width (ft)	7.71

- ◆ Cross-Section #1: UT to Middle Fork Creek Site F, Station 41+00, midpoint of riffle
- ◆ Cross-Section #2: UT to Middle Fork Creek Site F, Station 124+00, midpoint of pool

Based on comparisons of the As-Built to Year 1 monitoring data, all of the cross sections appear stable with little or no active bank erosion. Graphs of the cross sections are presented in Appendix A. Future survey data will vary depending on actual location of rod placement and alignment; however, this information should remain similar in appearance. The longitudinal profile showed that the channel was stable for the 2010 monitoring evaluation. Pebble counts were not required per the permit conditions and therefore were not completed.

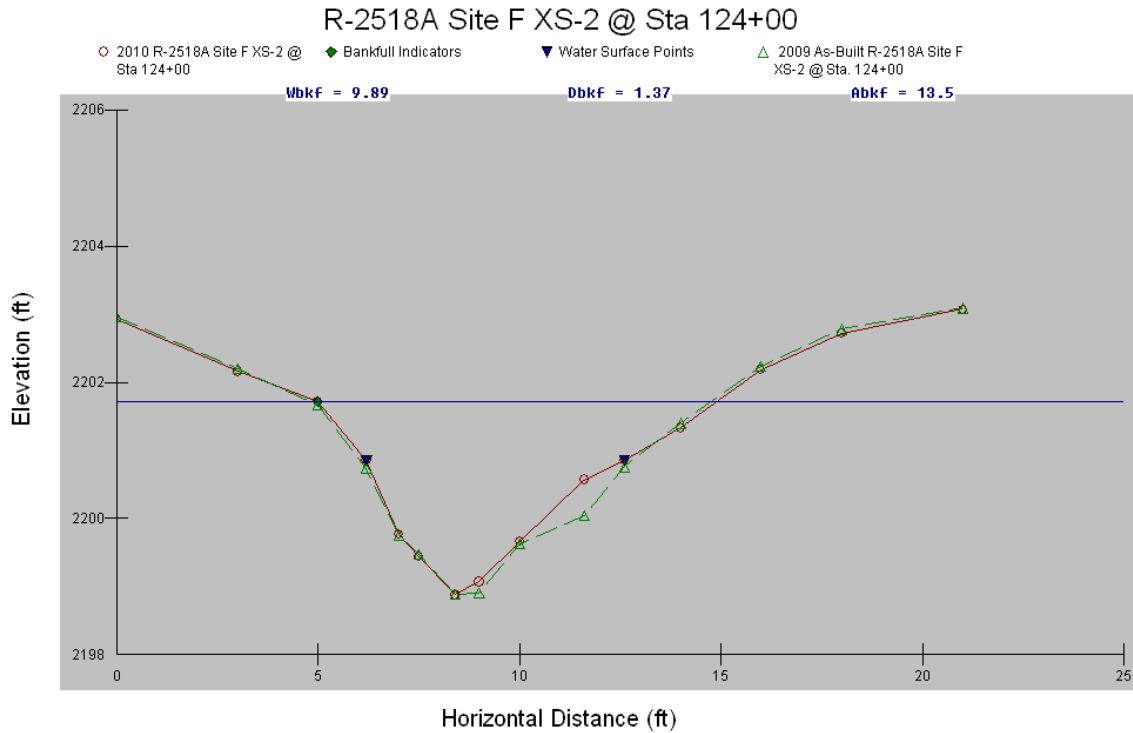
Site F: Cross-Section #2 (Pool) Abbreviated Morphological Summary					
	2010	2011	2012	2013	2014
Bankfull Cross Sectional Area (ft ²)	13.55				
Maximum Bankfull Depth (ft)	2.83				
Bankfull Mean Depth (ft)	1.37				
Bankfull Width (ft)	9.89

*According to the Rosgen Classification of Natural Rivers floodprone width, entrenchment ratio, and width depth ratio are not measured in pool, glide, or run features.

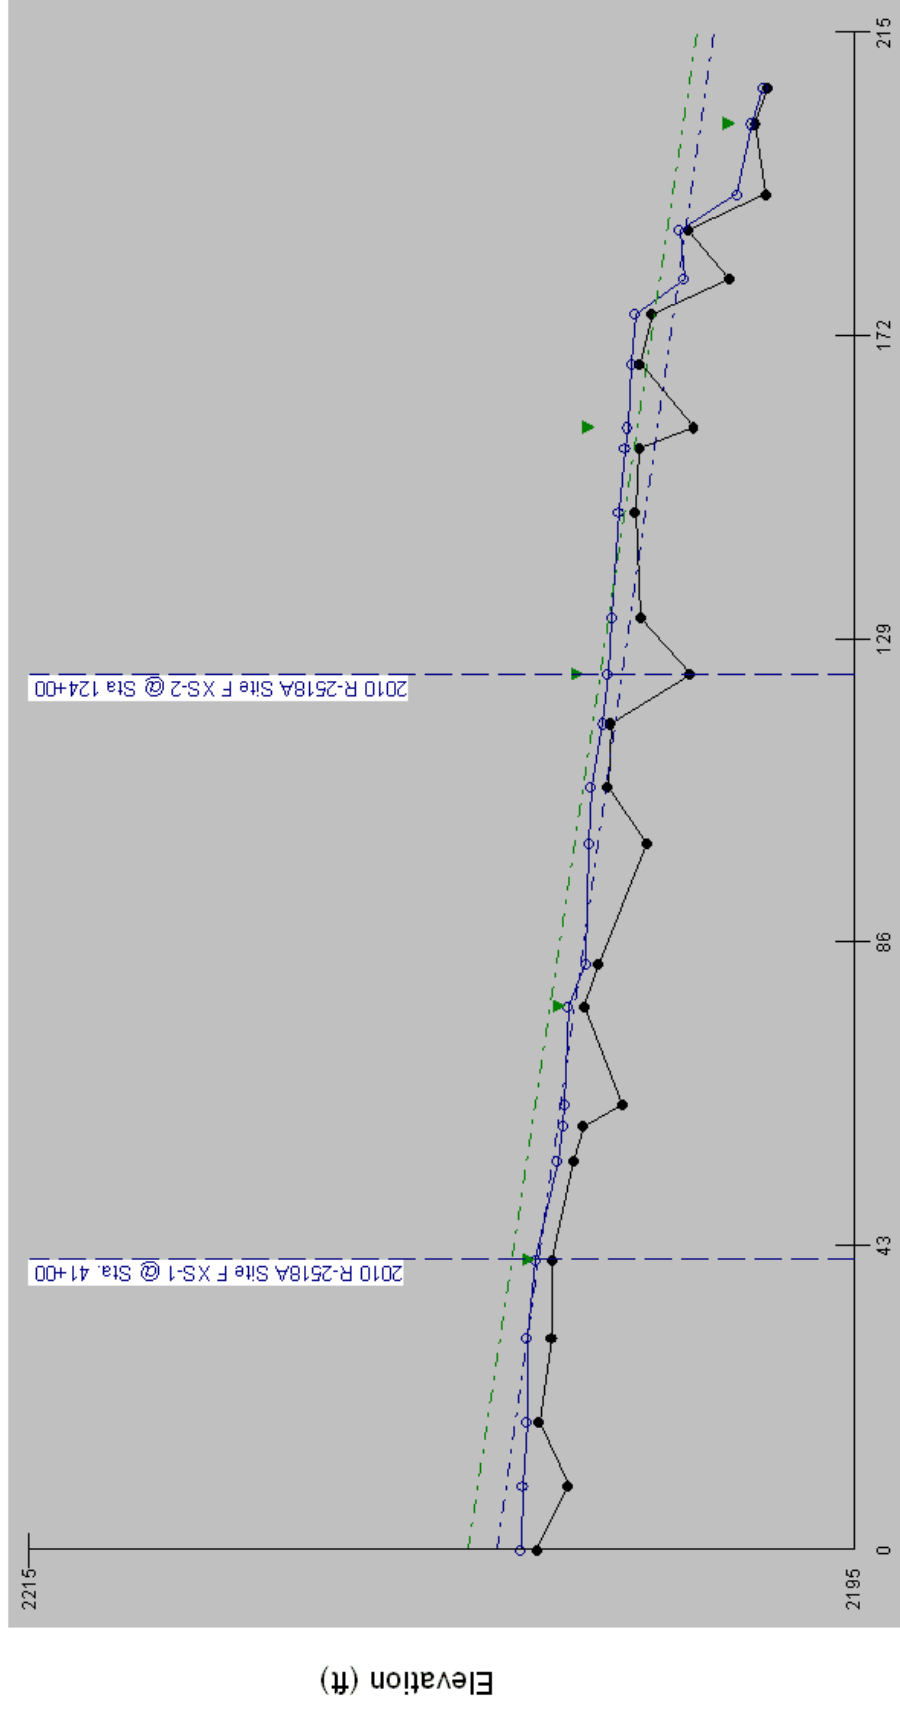
This cross-section plot displays elevation data for two survey points, XS-1 and XS-2, along a stationing axis. The vertical axis represents Elevation in feet, ranging from 2195 to 2215. The horizontal axis represents Stationing, with major markers at 0, 43, 86, 129, 172, and 215. Two data series are plotted: 2010 R-2518A Site F XS-1 (represented by blue circles and a dashed blue line) and 2010 R-2518A Site F XS-2 (represented by black circles and a solid black line). Both series show a general upward trend in elevation as stationing increases. XS-1 starts at approximately 2196.5 ft at station 0 and reaches about 2214.5 ft at station 215. XS-2 starts at approximately 2196.5 ft at station 0 and reaches about 2214.5 ft at station 215. A vertical dashed line is drawn at station 43, and a horizontal dashed line is drawn at elevation 2200. A legend in the bottom right corner identifies the two data series.

2010 R-2518A Site F XS-1 @ Sta. 41+00

2010 R-2518A Site F XS-2 @ Sta 124+00

The assessment included the survey of two cross sections and the longitudinal profile of the UT to Middle Fork Creek Site F established by NCDOT after construction. The length of the profile along the UT to Middle Fork Creek Site F was approximately 207 linear feet. Two cross sections were established during the as-built monitoring year. Cross section locations were subsequently based on the stationing of the longitudinal profile and are presented below. The location of the cross sections and longitudinal profile are shown in Appendix A.
